**WILLIAMS LAKE DAM**

MA. 00451

**PHASE I INSPECTION REPORT  
NATIONAL DAM INSPECTION PROGRAM**

DECEMBER 1980

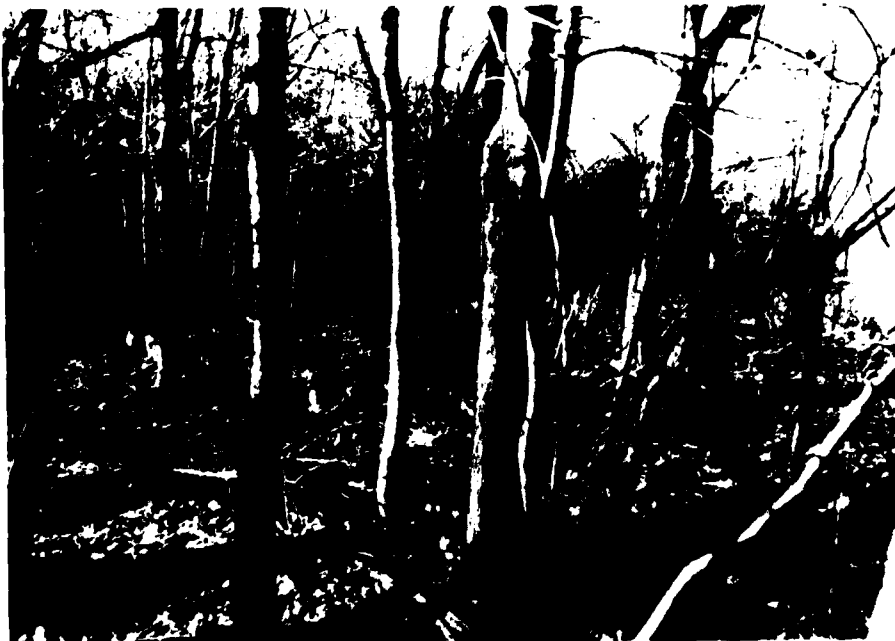
Abundant brush and tree growth extends along the entire length of the dam. (see Appendix C, Photo Nos. 1 & 2). The downstream stone wall is tilting in the downstream direction and a section of the wall has moved outward and is essentially demolished (see Appendix C, Photo Nos. 3 & 4). At the time of the inspection, there was no seepage observed along the downstream toe of the wall area. The upstream slope of the dam is irregular and and overgrown with trees. The crest of the dam shows signs of trespassing as there is a footpath which passes along the entire length of the dam.

4. View of deteriorated downstream stone wall from left abutment.

(2) Repair the downstream rubble masonry walls.
